## Troubleshooting RTDs and Thermocouples

Troubleshooting RTDs and Thermocouples

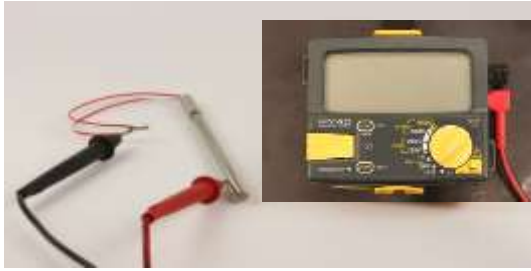
### Test method

- Lower resistance = lower measured temperature
- Test at 50 VDC minimum
- IR should be >100 megohms at 25°C

IR decreases with an increase in temperature so at room temperature a value much higher than what is really needed for an accurate measurement is required.

An industrial grade RTD accuracy is not significantly affected until the IR drops below a few megohms. The measurement is made by touching one lead of a megohmmeter to the leads and the other to the probe sheath. Some industrial grade probes are tested to higher levels to insure maximum performance at high temperatures.

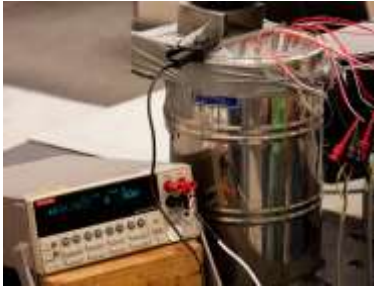
### Verification in an ice bath

- Resistance at 0°C most important and easiest to check
- Standard interchangeability tolerances established by either ASTM E1137, or IEC 60751

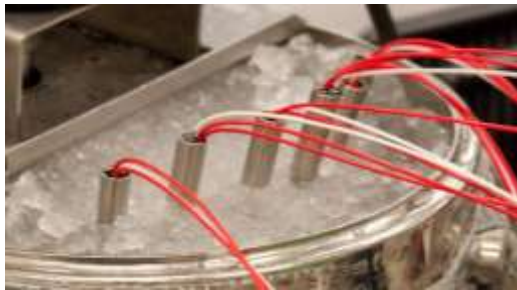
Using an Ice Bath and DMM, check resistance at 0°C

Crushed ice, purified water, and an insulated container

Crushed ice made with purified water is packed into an insulated container. Purified water is added to fill in the gaps. If the ice floats, you have added too much water. Adding a stirring feature to keep the water flowing around the ice minimizes temperature gradients within the bath. Each probe should be immersed at least 4". Do not use the probe to beat a hole in the ice. You may damage the sensing element. Use a scrap probe or similar size rod to form the holes.

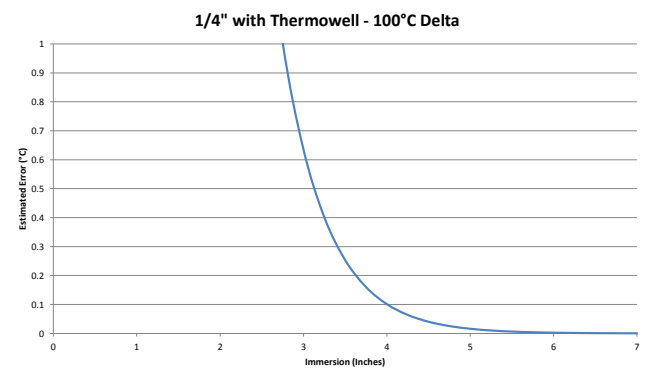
## Stem Conduction Error 15

This graph shows the affect of stem conduction error on a 1/4" diameter RTD installed in a thermowell and a 100C differential between ambient and process. As the immersion length is increased the error decreases. Also note that if the delta is decreased the error also decreases and goes to zero when ambient equals the process temperature.

Stem conduction is the most common cause of a measurement error. Insufficient immersion of the probe in the process to overcome the effects of ambient conditions is the main cause. Other sources can be radiation from a near by heat source, fan blowing on the sensor, or a probe that is not fitted properly in a thermowell.

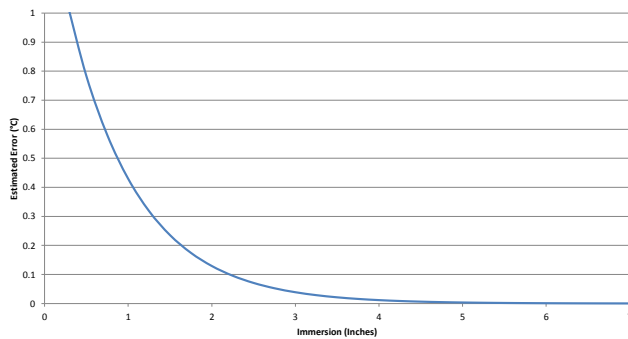
1/8" Diameter Short Immersion Design, 100°C Delta

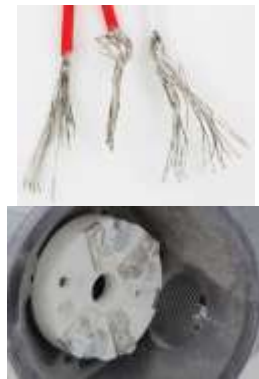
and bad

The connection head shown in the lower right corner had a lot of dust in it that caused some electrical leakage between the terminals resulting in a bad temperature reading.

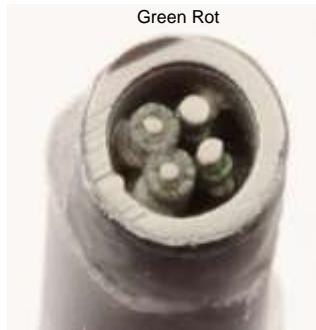
Green Rot

- Severely oxidized or corroded thermocouples should be replaced.
- Changes in wire composition can result from corrosion and contamination by elements such as sulfur and iron.
- Green rot of a type K is caused by too little oxygen at 800°C to 1,040°C.
  - Non-magnetic chromel wire will become magnetic.
