Error Sources for PRTs - Insulation Resistance - Part 2

Error Sources That Effect Platinum Resistance Thermometer Accuracy Part 2 – Insulation Resistance

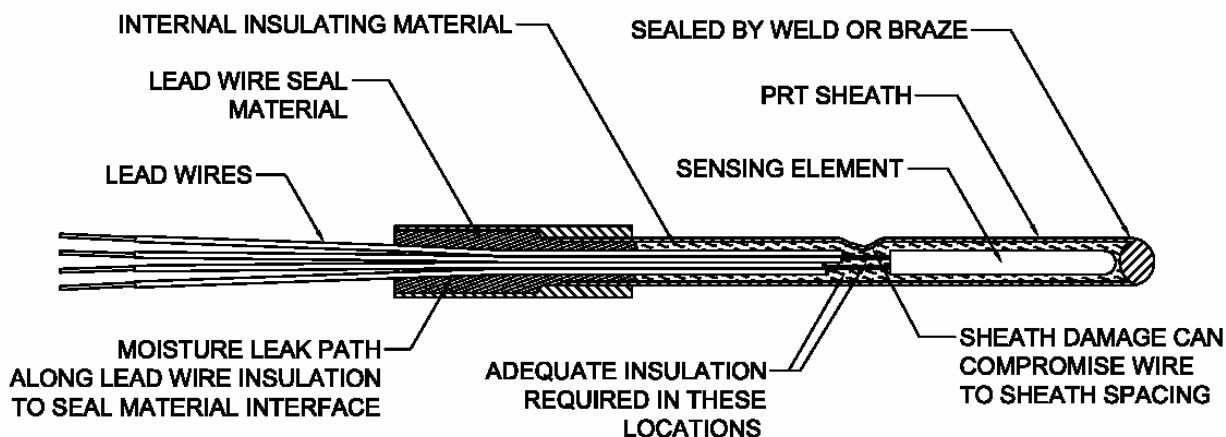
Figure 2.1 Cross Sectional View of a Typical Industrial PRT Showing Pertinent Insulation Resistance Information.

Insulation resistance values can degrade due to several sources. The most common source is moisture inside the PRT. The moisture may be trapped within the PRT during manufacture or generated within the PRT through outgassing of some material used in the construction of the PRT. Moisture may also enter the PRT through a leak path, most typically through the lead wire seal area.

Low IR could also be due to contamination within the PRT from sources other than moisture. In addition, bending, denting, vibration and mechanical shock of the PRT may result in displacement or migration of insulating materials producing inadequate spacing between the lead wire and sheath resulting in low IR.

In any case, it is impractical to repair PRTs with low IR. In some instances heating the PRT in an oven can “bake out” moisture that is within the sensor but if the moisture entered the PRT through a leak path, then the repair will only be temporary and moisture will most likely reenter through the same leak path. Refer to Figure 2.1 for additional details.
