Thermowell Condition Indicator

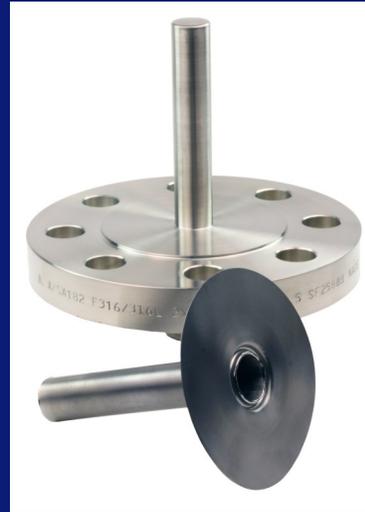
15673

▶ Thermowell w/ Flange Process Connection and Tantalum sleeve

Two solutions were offered as visual indicators of a well failure. First was to add a 1/8" diameter weep hole drilled into the instrument connection portion of the thermowell and is a very simple inexpensive solution. This still allows a small amount of fluid to escape in the event of a failure which may not be desirable. The second option effectively seals the thermowell instrument connection with a probe style that has a welded NPT connection. Then a tapped hole is added to the instrument connection housing and a pressure gauge is installed. Taking this one step further the gauge can be connected to a visual or audible alarm for complete containment and rapid notice of a failure.
